Contract #: 04-0120F4Cty: SF/ALA Rte: 80 PM: 13.2/13.9File #: 13.28**WELDING INSPECTION REPORT****Resident Engineer:**Pursell, Gary**Address:** 333 Burma Road**City:** Oakland, CA 94607**Report No:** WIR-011835**Date Inspected:** 01-Feb-2010**Project Name:** SAS Superstructure**OSM Arrival Time:** 1000**Prime Contractor:** American Bridge/Fluor Enterprises, a JV**OSM Departure Time:** 1830**Contractor:** Oregon Iron Works Clackamas, Or.**Location:** Clackamas, OR

## WELDING INSPECTION REPORT

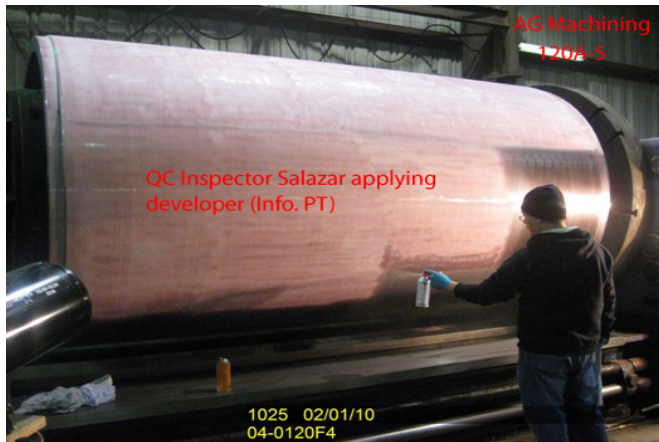
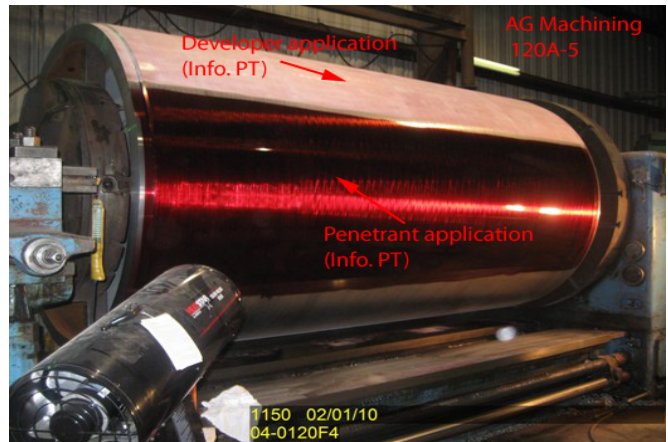
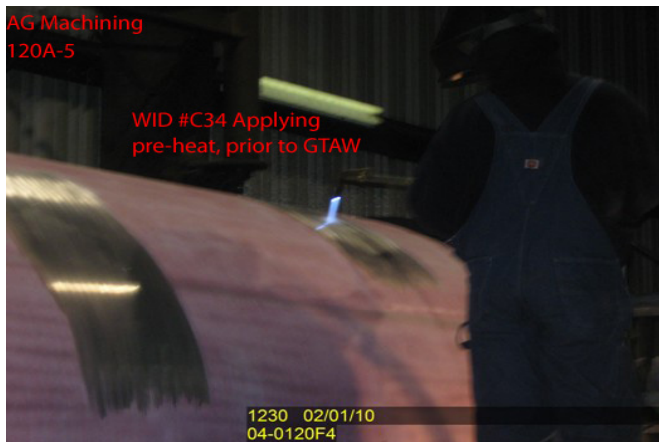
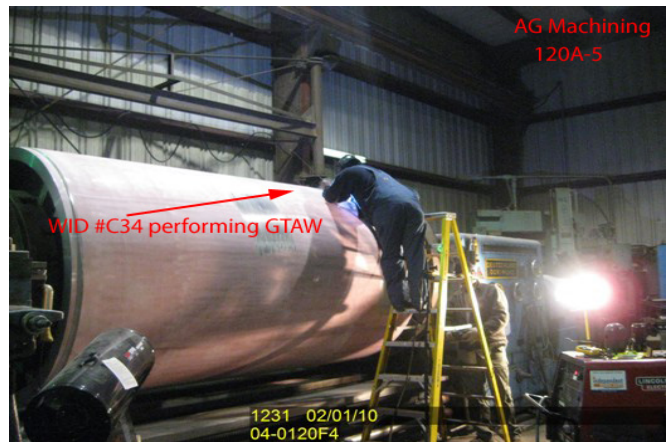
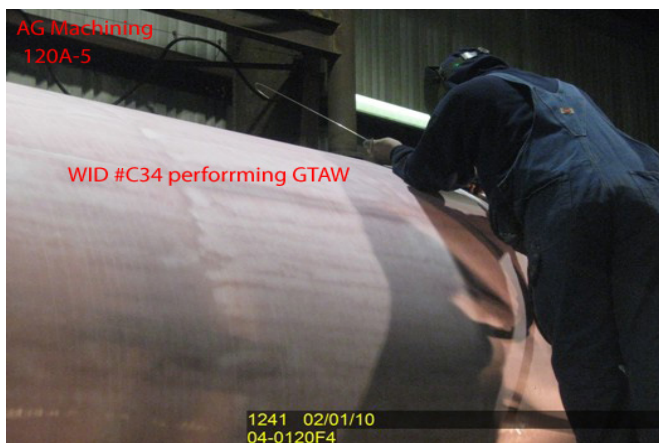
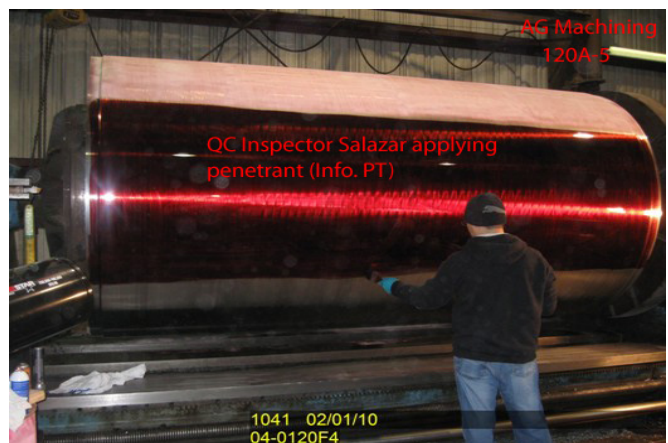
On this date, the QA Inspector arrived at AG Machine to observe OIW perform informal penetrant testing and weld repairs, on the finished overlay surface, on this Fuse 120A-5. The QA Inspector met with OIW QC Inspector Jose Salazar, OIW welder (WID# C34) Mark Craig an OIW and AG Machinist. QC Inspector Salazar explained to the QA Inspector that he was instructed to perform informal PT on 100% of the overlay and Mr. Craig will perform the GTAW weld repairs. The QA Inspector noted that the indications, currently present in the overlay, appeared after AG completed the final cut pass and finish honing. QC Inspector Salazar informed the QA Inspector that per the approved OIW Liquid Penetrant testing (PT) procedure QC-114 the piece to be examined should be at a minimum of 70 degrees Fahrenheit. For this inspection OIW are attempting to locate any discrepancy that would need to be repaired prior to final inspection. Once all repairs are complete, OIW will later perform a formal PT inspection on 100% of the Fuse overlay per the approved PT procedure. The QA Inspector witnessed QC Inspector Jose Salazar in process of cleaning "sections" on the overlay with acetone/cleaner and also later applying penetrant and developer. The QA Inspector spoke with Mr. Salazar who explained that any surface indications that were present during the informational PT testing would be marked for repairing and OIW welder Mark Craig would then grind out and perform GTAW on the repairs. QC Inspector Salazar informed the QA Inspector that multiple indications were present, during the PT testing, which appeared to be small clusters of

slag inclusions. The QA Inspector witnessed Mr. Craig grinding out these indications, to a depth of .5-1 mm and then later setting up to perform the GTAW.

The QA Inspector noted that Mr. Craig was currently qualified to perform these repairs and would be utilizing welding procedure specification (WPS 8022). The QA Inspector witnessed Mr. Craig performing the pre-heat required, utilizing a torch and then observed a temperature of approximately 150 degrees Fahrenheit, after the pre-heat was complete. The QA Inspector noted that 125 degrees Fahrenheit minimum was required, per WPS 8022. The QA Inspector witnessed AG Machinist rotating the fuse assembly to access the weld repair areas in the flat position. The QA Inspector then observed Mr. Mark Craig performing the GTAW on the previously excavated repair areas. The QA Inspector also observed QC Inspector Jose Salazar recording the in-process welding parameters of 121 amps and 16.5 volts. The QA Inspector also verified these welding parameters. The QA Inspector noted that after completion of these weld repair areas, the OIW Machinist performed the grinding with a buffer wheel on the completed weld repair to "flush" with the finished overlay surface. The QA Inspector observed that the Fuse was then rotated and the QC Inspector performed 100% informational PT Inspection on another section of the finished overlay. The QA Inspector also observed several more indications that would need to go through the above mentioned repair procedure. The QA Inspector observed that Mr. Salazar was present the entire time in which the GTAW welding was being performed.

The QA Inspector later spoke with QC Inspector Salazar and Mr. Salazar explained that the informational PT testing was complete and there were a total of 12 GTAW repair spots. See attached pictures below.

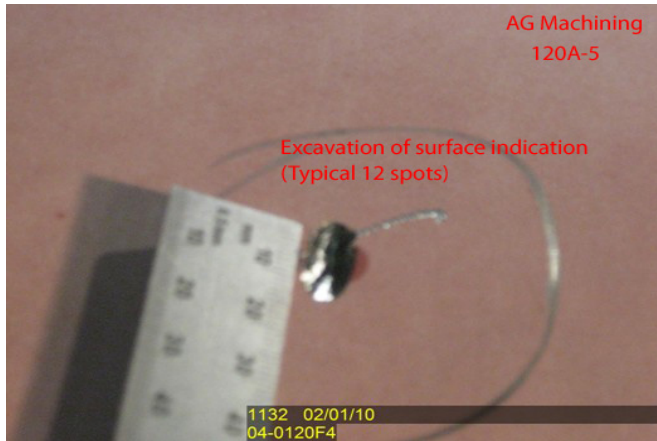
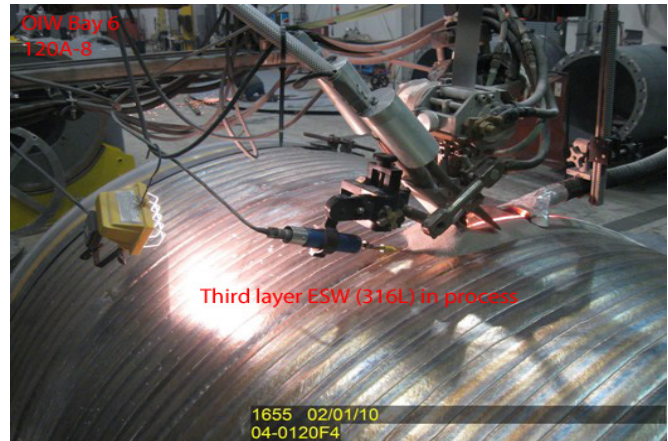
Hinge-K Pipe Beam Fuse Assembly 120A-8

The QA Inspector was present on this swing shift and witnessed WID#V7, Mr. Vincent Vue continuing to perform electro slag welding (ESW) on the third layer ESW welding passes, utilizing the 316L stainless steel consumable strip, in the flat position. The QA Inspector randomly noticed QC Inspector Gary Mundt was present, to verify in-process welding parameters (amps/volts) and monitor in-process continuous pre-heat temperatures. QC Inspector Mundt explained to the QA Inspector that welding amperage was previously recorded at 1300 amps/25 volts, travel speed of 267mm/min. and a pre-heat temperature recorded at 150 degrees Fahrenheit (66C). The QA Inspector randomly verified pre-heat temperature of approximately 150 degrees Fahrenheit (66 C) and noted that the ESW being performed, appeared to be in compliance with the applicable welding procedure specification (WPS) 7003. See attached picture below.

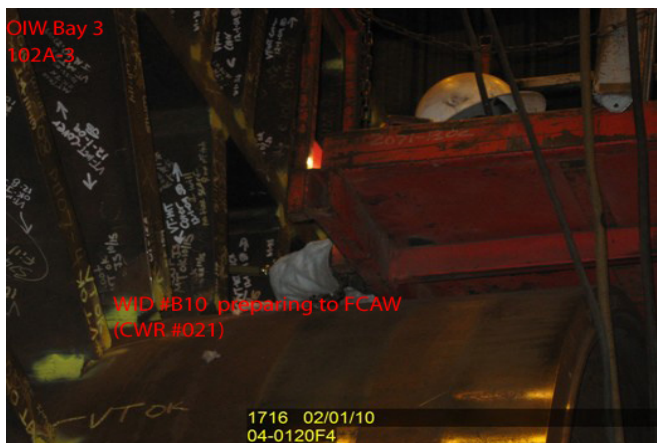
Hinge-K Pipe Beam Assembly 102A-3

a111-3 Forging to a110-3 Base Plate

The QA Inspector was notified by OIW swing shift QC Inspector Gary Mundt that WID #B10 (Liem Bui), was in process of setting up, to perform Critical Weld Repairs #2244-021 and #2244-014. QC Inspector Mundt explained that the FCAW will be performed to the OIW approved Welding Procedure Specification (WPS) 3051. QC Mundt explained that he will be present during the entire shift to continuously monitor welding parameters (amps/volts) and pre-heat temperatures, during the CWR's. QC Inspector Mundt explained that WID #B10 currently has a copy of the approved WPS and the QA Inspector verified this. See attached picture below.
